Quick Response
Statement of Work
Kootenai River Development
875 US Highway 2 (Valve House at Stimson Finger-Jointer
Building)

QUICK RESPONSE STATEMENT OF WORK
 875 US HIGHWAY 2
 VALVE HOUSE B9-B10 AT FINGER JOINTER BUILDING
 KOOTENAI RIVER DEVELOPMENT
 AD-00686

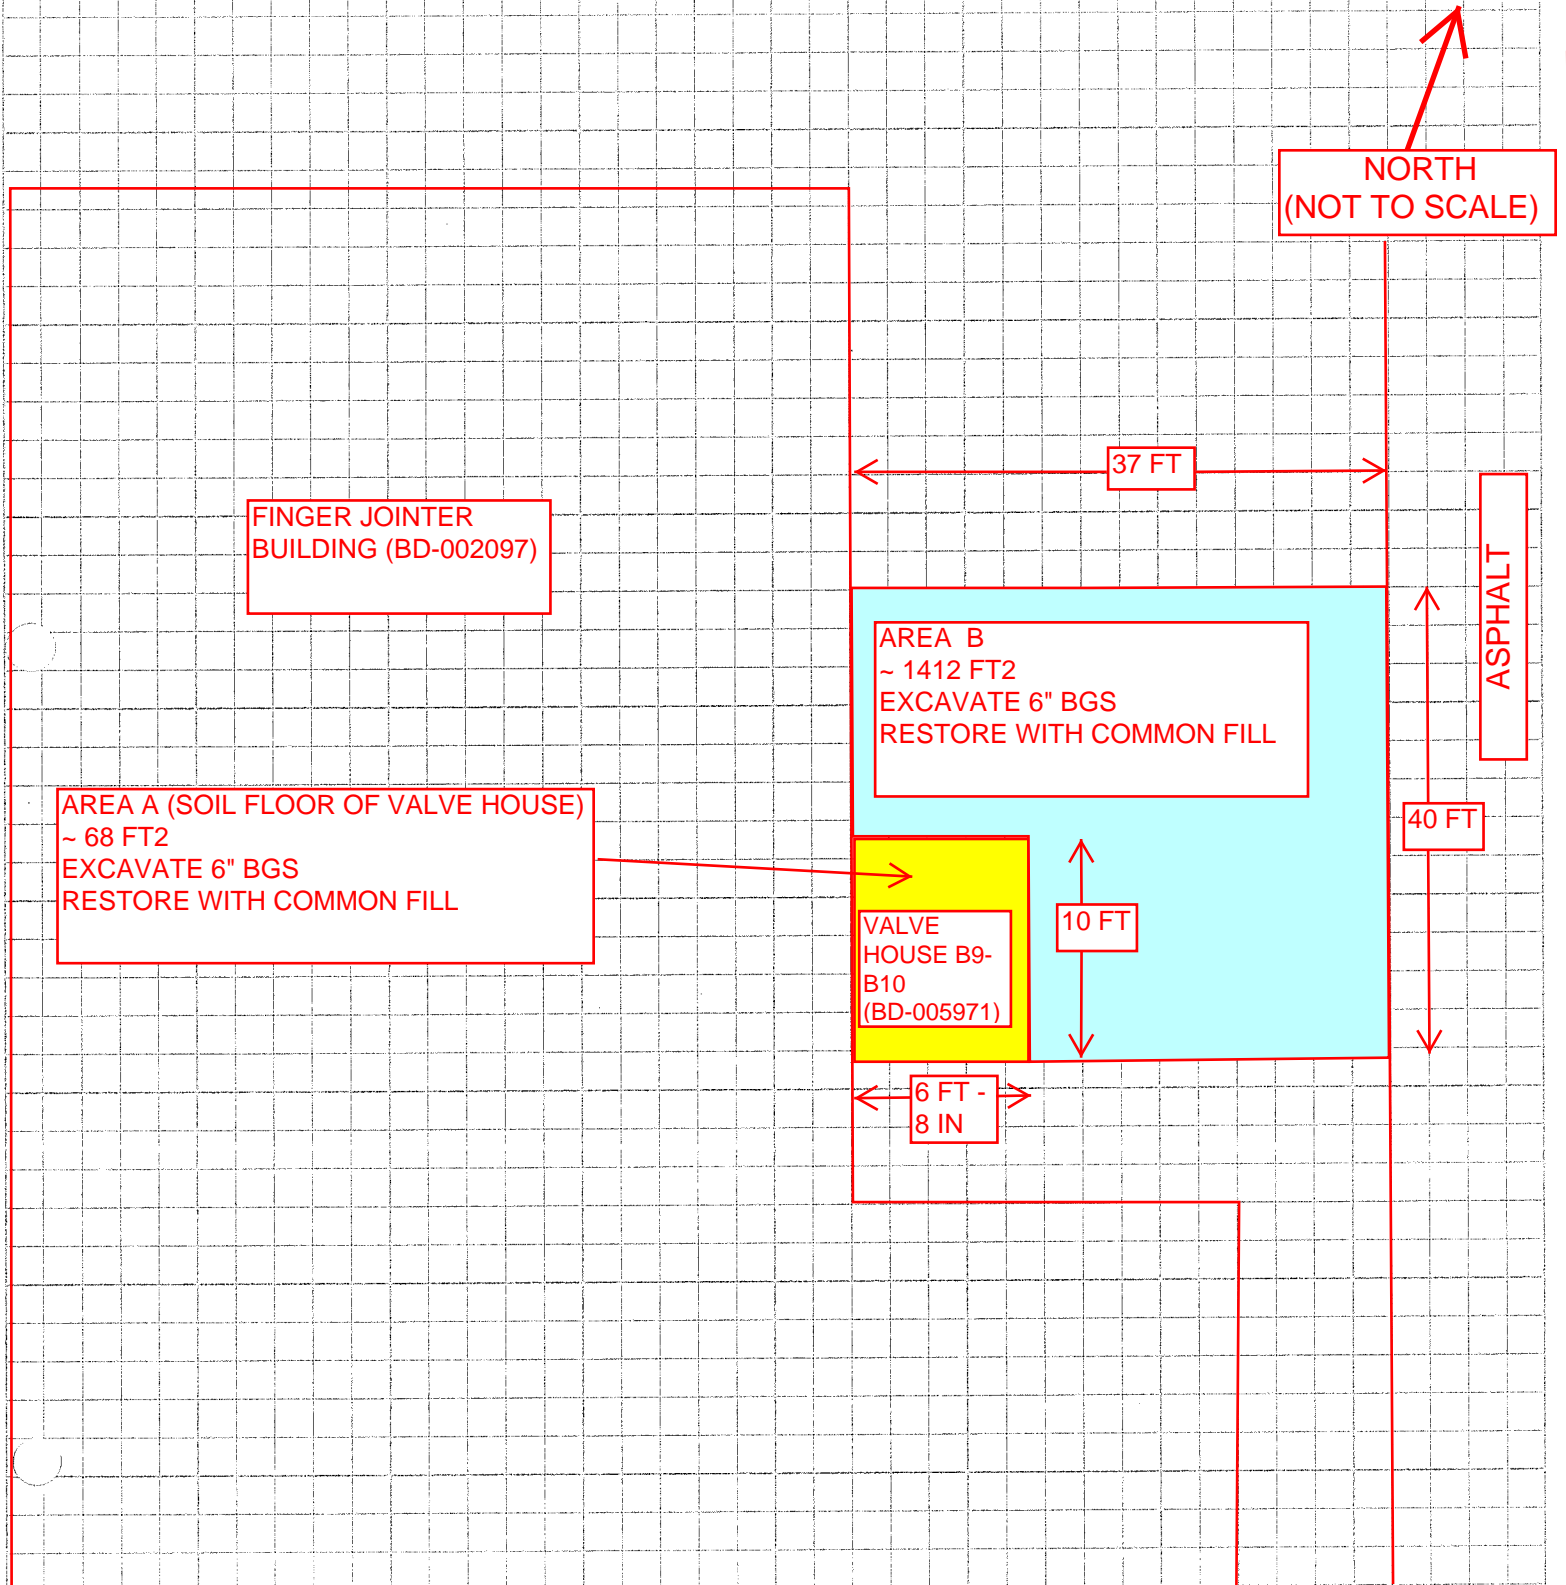
An ERS inspection in June 2010 revealed VCI in one of the valve houses (B9-B10). Vermiculite was also observed in the soil floor and along the ground surface of the building. The vermiculite appears to be originating from the inside wall cavities.

The removal contractor will excavate Area A to a depth of 6 inches below ground surface. This area is approximately 68 square feet, which will result in approximately 1 cubic yard of soil to be removed (see attached drawing for exact location). CDM will collect confirmation soil samples following excavation to determine if further soil removal is warranted.

The removal contractor will excavate Area B to a depth of 6 inches below ground surface. This area is approximately 1412 square feet, which will result in 27 cubic yards of soil to be removed (see attached drawing for exact location). CDM will collect confirmation soil samples following excavation to determine if further soil removal is warranted.

The excavated Area A will be restored by the removal contractor with 6 inches of common fill (1 cubic yard).

The excavated Area B will be restored by the removal contractor with 6 inches of common fill (27 cubic yards).
